SUBJECT: Site Inspection, Uintah County, Asphalt Ridge Mine, M/047/022, Uintah County, Utah

Date of Inspection: August 14, 2003  
Time of Inspection: about 10:30 to 11:15 a.m.  
Conditions: Partly cloudy, 80's  
Participants: Kim McDonald, Uintah County; Doug Jensen and Paul Baker, DOGM

M/047/022, Asphalt Ridge Mine, Uintah County

Inspection Dated: August 14, 2003; Report Dated: September 10, 2003

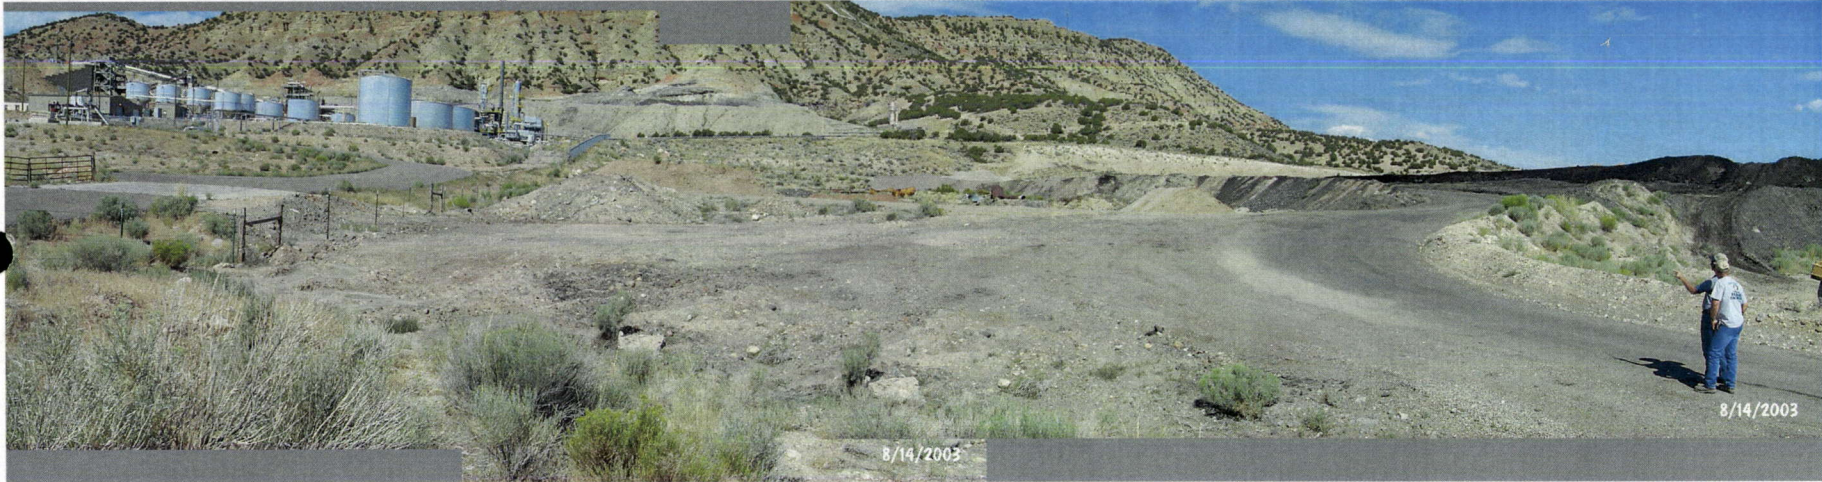
The area for the first pond, shown on the left side of Photo 1, is next to the road leading to the processing plant and would be used to contain drainage from the plant and some adjacent areas. The pond would be mostly incised.

**Photo 1.** The area on the left foreground portion of this photo is where Uintah county has proposed to put one of the sediment ponds.

The county needs to submit an amendment with information about the ponds, including location and design information, before building them. The ponds need to have spillways to reduce the risk of failure in the event of a large storm. Although the dams are likely to hold all runoff from most storms, any discharges would need to be sampled and tested and reported to the Division of Water Quality as part of the UPDES program. Depending on the design of the ponds and the likelihood for discharge, the county may need a permit to discharge. Any non-incised portion of a dam needs to be properly compacted and inspected as it being built.

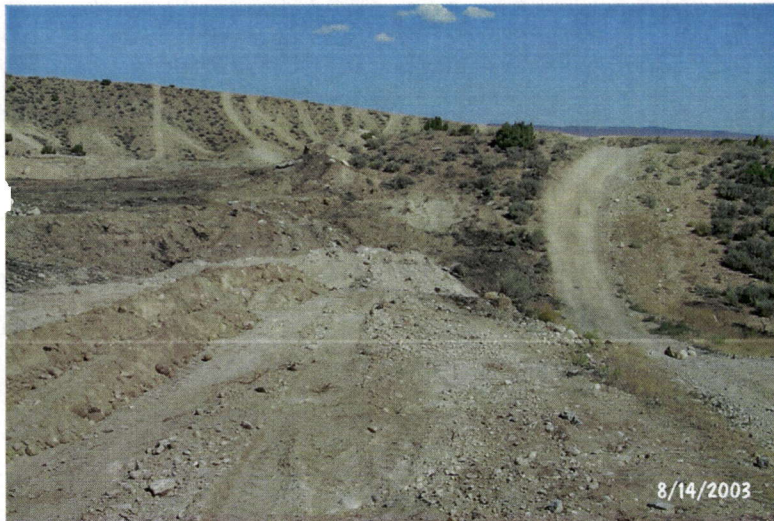
In the northeast part of the asphalt loading area, there is a small natural drainage where there used to be a culvert and where I had advised the operator to place a silt fence or

similar sediment control (Photo 2). The county had planned to place an embankment across this drainage to create an impoundment. Nearby, there is another area that was being graded in preparation for seeding this fall (Photo 3). This area is a natural depression and seemed like a logical place to put the pond. Because the depression is natural, there would be no chance of dam failure. The capacity would also be greatly increased compared to the location originally proposed. It was difficult to determine whether water from some parts of the disturbed area would flow to this area naturally or if drainage to the depression would need to be established.

**Photo 2.** The drainage just up from the road is where the county had planned to put a second impoundment.

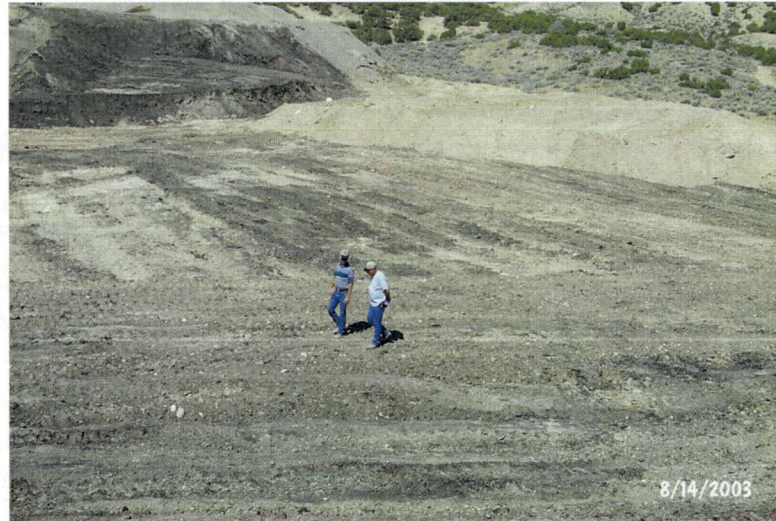
**Photo 3.** A natural depression being reclaimed where we discussed putting the second pond instead of the area shown in Photo 2.
